# Repairing a Burroughs Class 5 calculator

Francis Massen, Computarium  
[francis.massen@education.lu](mailto:francis.massen@education.lu)  
version 1.0a 03 Nov 2023

**Anne Baumann** donated a Burroughs Class 5 key punched or key driven calculator from the 1925's (serial = 5-476549, [Ref. 6]). This machine was bought at a flea-market in Switzerland. It was in a very pleasing visual state, but completely blocked: nothing moved, neither crank nor number wheels.

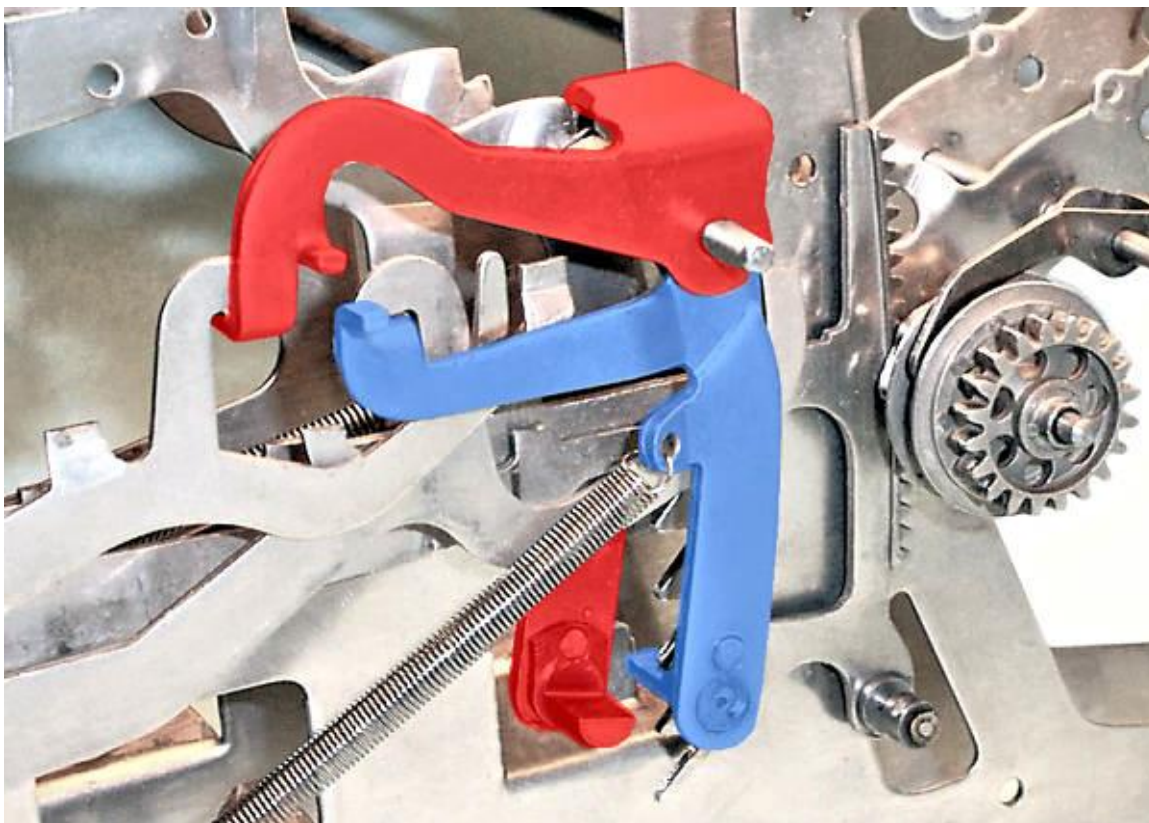
*Fig.1: This is the system on a Comptometer [Ref.2]: the toothed segment at the right moves down according to the key pressed and turns a toothed guiding wheel, which is freely rotating on its axis. When the key is released, a second part of that wheel now becomes fixed and transmits its rotation to another toothed wheel of the addition mechanism, turning that wheel by the number of teeth corresponding to the key pushed down (see later). [Comptometer, Ref. 2]*

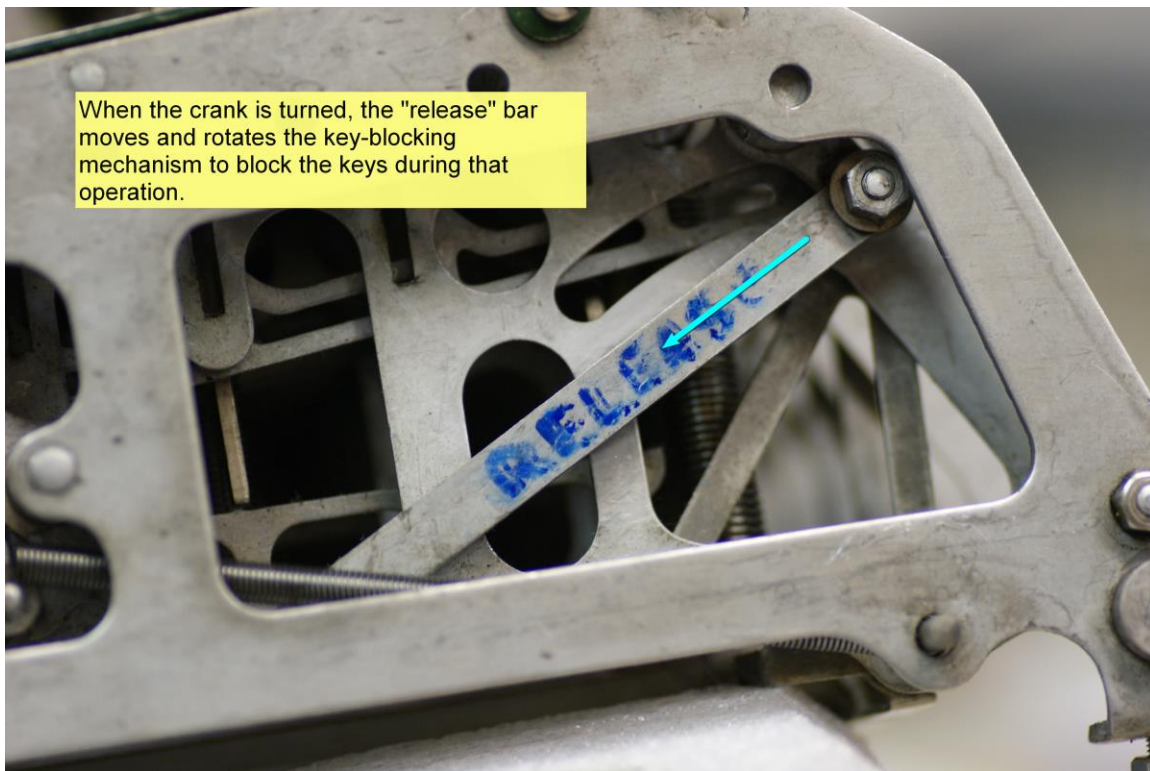
Keys must not be pressed when the crank is moving: Fig.11 shows a lever at the rear right side, which rotates a special axis to block all key movements.

When the crank is turned, the "release" bar moves and rotates the key-blocking mechanism to block the keys during that operation.

Fig.11: Lever pulled down in the direction of the blue arrow to rotate the key blocking axis

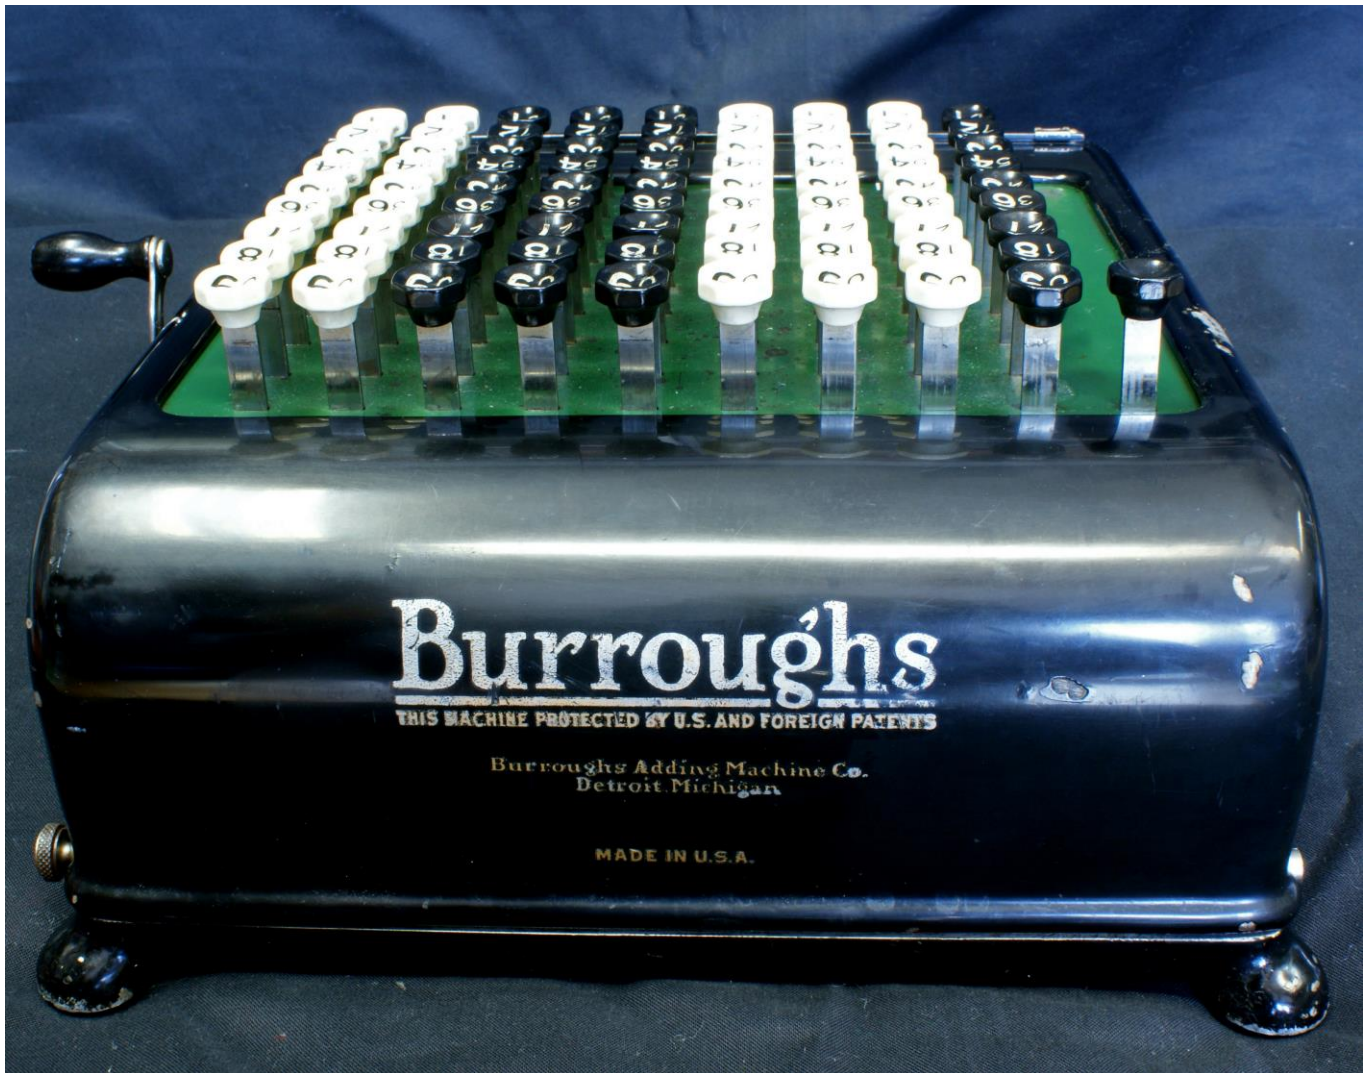
Fig.23: View from the rear; only one of the cover screws (here at the left of the picture) is the original.
